**Flood Control Project Maintenance
Levee Inspections**

Fall 2015 Levee Maintenance Deficiency Summary Report

City of Sacramento

**Flood Control Project Maintenance
Levee Inspections
Unit Cover Sheet
Fall 2015 Levee Inspection Results
City of Sacramento**

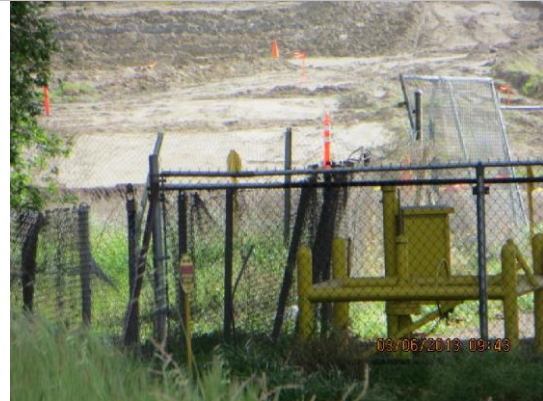
Photo 1 of 3 : UCIP_FA_2015_1742.jpg

LM Start	0.06	Rating **	M	Issue No.	827 (cont)
LM End	0.06	Issue Type +	En	Location *	N/A

View of multiple markers indicating gas alignment.

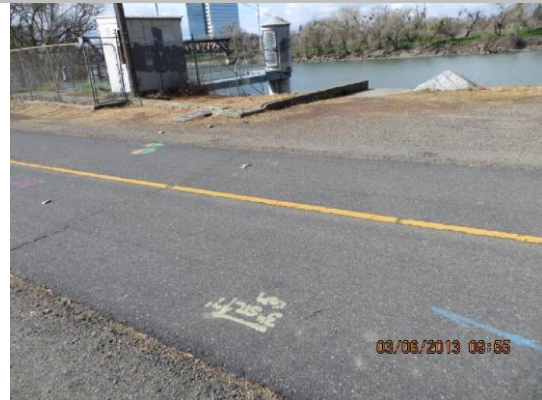
Photo 3 of 3 : UCIP_FA_2015_6331.jpg

LM Start	0.14	Rating **	M	Issue No.	828 (cont)
LM End	0.14	Issue Type +	En	Location *	N/A
Category	Supplemental			GPS Latitude/Longitude	
				Start	End
Item	DWR UCIP Field Study			38.588768 °	38.588768 °
				-121.504891 °	-121.504891 °
DWR ID					
Action/Comments					
Inspector Comments: FS_ID:41414 DS_ID:24882 EP_NO: N/A FS_HLM: 0.14 Repair Type: Non-Urgent Crossing Status: Indicator Found UCIP Comments: Need to contact owner to determine status of crossing. No permit found during desk study review. FIELD_STRUCT_DESC: 42 inch water transmission main through levee at unknown depth. Crossing installed in 1966. FS Date: 03/06/2013

View of levee crown and waterward side.

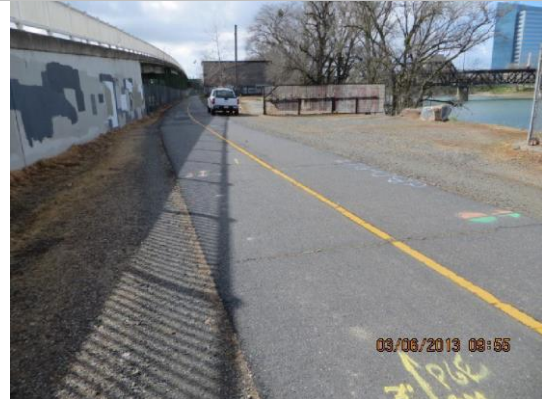
Photo 3 of 3 : UCIP_FA_2015_6336.jpg

LM Start	0.15	Rating **	U	Issue No.	830 (cont)
LM End	0.15	Issue Type +	En	Location *	N/A
Category	Supplemental			GPS Latitude/Longitude	
				Start	End
Item	DWR UCIP Field Study			38.588636 °	38.588636 °
				-121.504860 °	-121.504860 °
DWR ID					
Action/Comments					
Inspector Comments: FS_ID:40846					
DS_ID:24884					
EP_NO: N/A					
FS_HLM: 0.149					
Repair Type: Urgent					
Crossing Status: Indicator Found

View of levee crown and alignment of PG&E line visible by yellow paint markings.

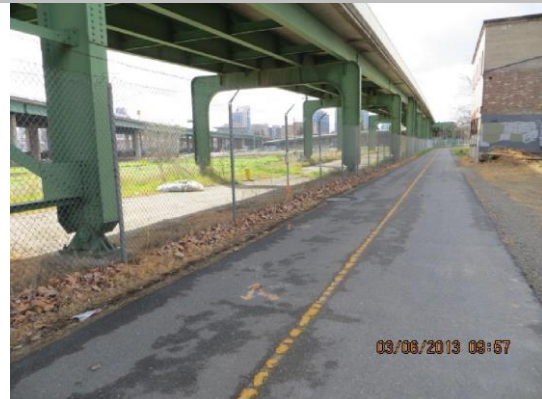
Photo 1 of 2 : UCIP_FA_2015_6337.jpg

LM Start	0.16	Rating **	M	Issue No.	831
LM End	0.16	Issue Type +	En	Location *	N/A
Category	Supplemental			GPS Latitude/Longitude	
				Start	End
Item	DWR UCIP Field Study			38.588500 °	38.588500 °
				-121.504856 °	-121.504856 °
DWR ID					
Action/Comments					
Inspector Comments: FS_ID:41416 DS_ID:24885 EP_NO: N/A FS_HLM: 0.158 Repair Type: Non-Urgent Crossing Status: Indicator Found UCIP Comments: No markers visible as per Title 23. Recommend having utility owner coordinate with Central Valley Flood Protection Board (CVFPB). FIELD_STRUCT_DESC: ATT communication line through levee at unknown depth. FS Date: 03/06/2013

Alignment of communication line through levee, Photo 2 of 2.

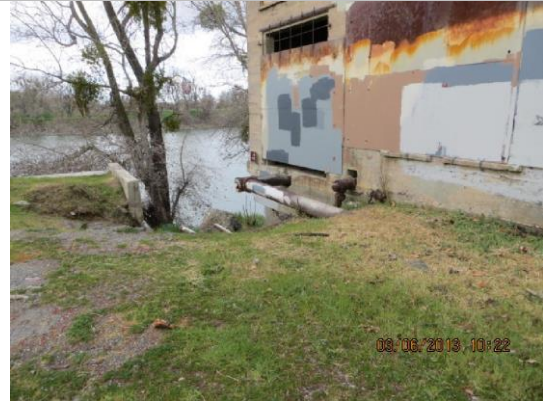
Photo 1 of 3 : UCIP_FA_2015_6333.jpg

Inspector Comments: FS_ID:40848
 DS_ID:24887
 EP_NO: N/A
 FS_HLM: 0.22
 Repair Type: Non-Urgent
 Crossing Status: Indicator Found
 UCIP Comments: Pump station appears non-functional. Owner will need to coordinate with DWR-Inspector and CVFPB to determine if crossing meets Title 23 requirements.
 FIELD_STRUCT_DESC: 12 inch connected to 10 inch pipe through levee at unknown depth.
 FS Date: 03/06/2013

View of building and additional concrete structures located on levee crown at waterward side.

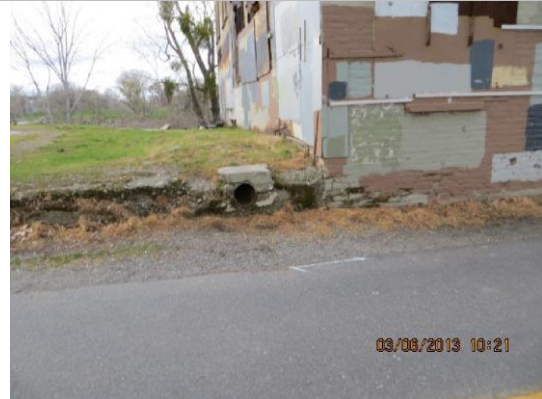
Photo 3 of 3 : UCIP_FA_2015_6341.jpg

LM Start	0.22	Rating **	M	Issue No.	833 (cont)
LM End	0.22	Issue Type +	En	Location *	N/A
Category	Supplemental			GPS Latitude/Longitude	
				Start	End
Item	DWR UCIP Field Study			38.587615 °	38.587615
				-121.505034 °	-121.505034
DWR ID					
Action/Comments					
Inspector Comments: FS_ID:40848					
DS_ID:24887					
EP_NO: N/A					
FS_HLM: 0.22					
Repair Type: Non-Urgent					
Crossing Status: Indicator Found

Pipe through levee visible next to building located on levee.

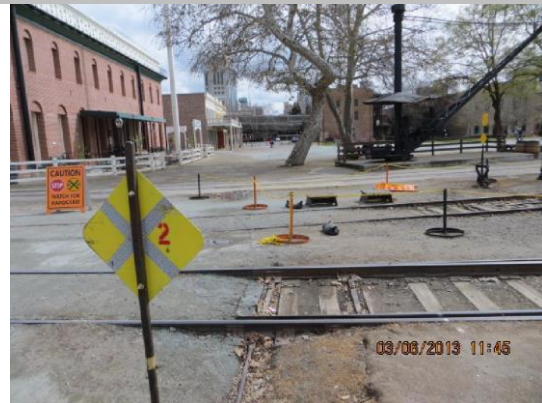
Photo 1 of 3 : UCIP_FA_2015_2044.jpg

LM Start	0.42	Rating **	M	Issue No.	836
LM End	0.42	Issue Type +	En	Location *	N/A
Category	Supplemental			GPS Latitude/Longitude	
				Start	End
Item	DWR UCIP Field Study			38.584762 °	38.584762 °
				-121.505556 °	-121.505556 °
DWR ID					
Action/Comments					
Inspector Comments: FS_ID:20384 DS_ID:21561 EP_NO: N/A FS_HLM: 0.422 Repair Type: Non-Urgent Crossing Status: Indicator Found UCIP Comments: Only manhole was visible; need to determine condition of crossing; Will need to follow up with the City of Sacramento. FIELD_STRUCT_DESC: 18-inch-diameter storm drain through the levee, 5 feet below the crown. Concrete surge box on the waterward side of the retaining wall. Concrete box spillway. FS Date: 03/06/2013

View of landward side close to railroad museum.

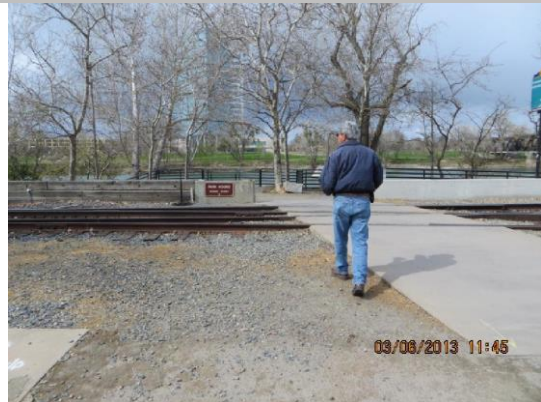
Photo 3 of 3 : UCIP_FA_2015_2046.jpg

LM Start	0.42	Rating **	M	Issue No.	836 (cont)	
LM End	0.42	Issue Type +	En	Location *	N/A	
Category	Supplemental			GPS Latitude/Longitude		
				Start	End	
Item	DWR UCIP Field Study			38.584762 °	38.584762 °	
				-121.505556 °	-121.505556 °	
DWR ID						
Action/Comments						
Inspector Comments: FS_ID:20384 DS_ID:21561 EP_NO: N/A FS_HLM: 0.422 Repair Type: Non-Urgent Crossing Status: Indicator Found UCIP Comments: Only manhole was visible; need to determine condition of crossing; Will need to follow up with the City of Sacramento. FIELD_STRUCT_DESC: 18-inch-diameter storm drain through the levee, 5 feet below the crown. Concrete surge box on the waterward side of the retaining wall. Concrete box spillway. FS Date: 03/06/2013

View of levee crown downtown Sacramento--wide crown with railroad.

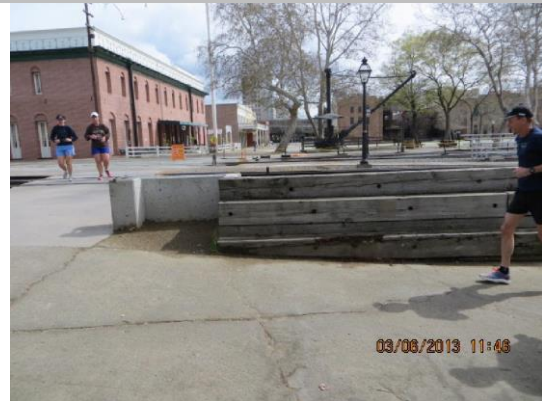
Photo 1 of 3 : UCIP_FA_2015_6342.jpg

LM Start	0.42	Rating **	M	Issue No.	838
LM End	0.42	Issue Type +	En	Location *	N/A
Category	Supplemental			GPS Latitude/Longitude	
				Start	End
Item	DWR UCIP Field Study			38.584767 °	38.584767 °
				-121.505700 °	-121.505700 °
DWR ID					
Action/Comments					
Inspector Comments: FS_ID:41417 DS_ID:24890 EP_NO: N/A FS_HLM: 0.424 Repair Type: Non-Urgent Crossing Status: Indicator Found UCIP Comments: Need additional information about crossing--depth of pipe, owner, status, and permit. FIELD_STRUCT_DESC: Submarine cable from the bed of the Sacramento River through and along the natural west levee of the river at a depth of 2 feet to a point in the town of Broderick, opposite a point approximately 434 feet downstream from the "I" Street Bridge, Sacramento. (Permit No. 881, 1942) FS Date: 03/06/2013

View of landward side.

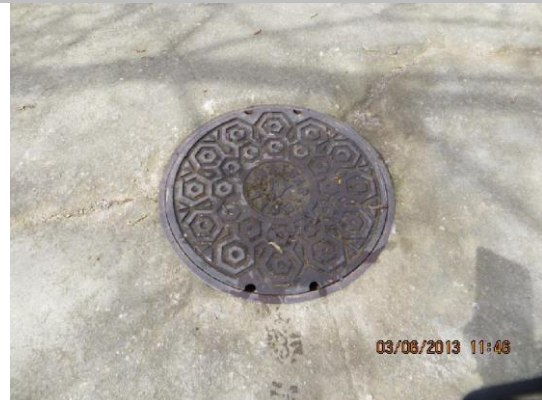
Photo 3 of 3 : UCIP_FA_2015_6344.jpg

LM Start	0.42	Rating **	M	Issue No.	838 (cont)	
LM End	0.42	Issue Type +	En	Location *	N/A	
Category	Supplemental			GPS Latitude/Longitude		
				Start	End	
Item	DWR UCIP Field Study			38.584767 °	38.584767 °	
				-121.505700 °	-121.505700 °	
DWR ID						
Action/Comments						
Inspector Comments: FS_ID:41417 DS_ID:24890 EP_NO: N/A FS_HLM: 0.424 Repair Type: Non-Urgent Crossing Status: Indicator Found UCIP Comments: Need additional information about crossing--depth of pipe, owner, status, and permit. FIELD_STRUCT_DESC: Submarine cable from the bed of the Sacramento River through and along the natural west levee of the river at a depth of 2 feet to a point in the town of Broderick, opposite a point approximately 434 feet downstream from the "I" Street Bridge, Sacramento. (Permit No. 881, 1942) FS Date: 03/06/2013

PacBell manhole located on waterward side.

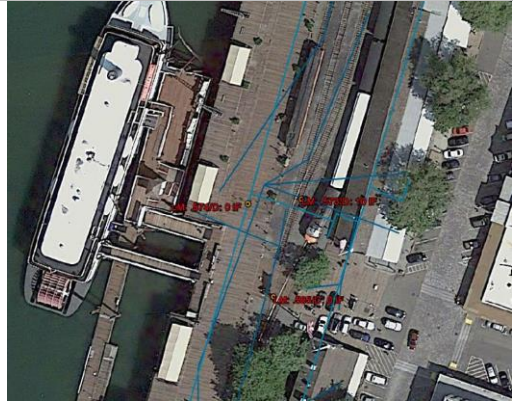
Photo 1 of 1 : UCIP_FA_2015_5928.jpg

LM Start	0.57	Rating **	M	Issue No.	841
LM End	0.57	Issue Type +	En	Location *	N/A
Category	Supplemental			GPS Latitude/Longitude	
				Start	End
Item	DWR UCIP Field Study			38.582700 °	38.582700 °
				-121.506266 °	-121.506266 °
DWR ID					
Action/Comments					
Inspector Comments: FS_ID:41419 DS_ID:24895 EP_NO: N/A FS_HLM: 0.573 Repair Type: Non-Urgent Crossing Status: Indicator Found UCIP Comments: Need to confirm if crossing is still present. No signs visible during site visit. No photos available. FIELD_STRUCT_DESC: 10 inch line through levee. Record found in Sacramento County GIS records. FS Date: 03/06/2013

Approximate alignment provided by the City of Sacramento--unable to confirm crossing in field.

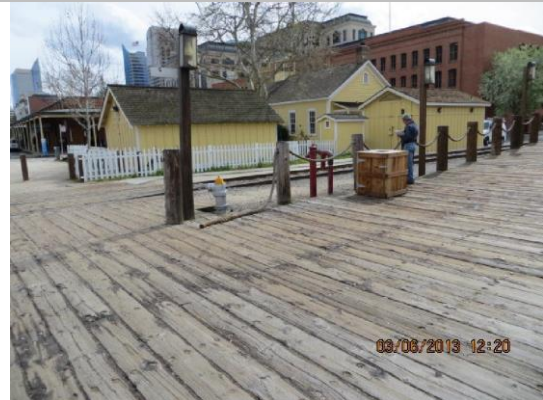
Photo 1 of 1 : UCIP_FA_2015_5933.jpg

LM Start	0.67	Rating **	M	Issue No.	846
LM End	0.67	Issue Type +	En	Location *	N/A
Category	Supplemental			GPS Latitude/Longitude	
				Start	End
Item	DWR UCIP Field Study			38.581332 °	38.581332 °
				-121.506853 °	-121.506853 °
DWR ID					
Action/Comments					
Inspector Comments: FS_ID:41266 DS_ID:24900 EP_NO: N/A FS_HLM: 0.668 Repair Type: Non-Urgent Crossing Status: Indicator Found UCIP Comments: Unable to confirm if crossing goes through levee. Need to contact owner to determine alignment for crossing. FIELD_STRUCT_DESC: Fire hydrant visible on levee crown located in downtown Sacramento. FS Date: 03/06/2013

Fire hydrant visible on levee crown.

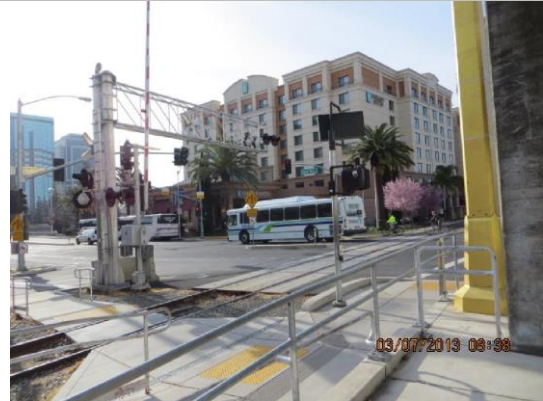
Photo 1 of 3 : UCIP_FA_2015_5934.jpg

LM Start	0.73	Rating **	M	Issue No.	851
LM End	0.73	Issue Type +	En	Location *	N/A
Category	Supplemental			GPS Latitude/Longitude	
				Start	End
Item	DWR UCIP Field Study			38.580413 °	38.580413 °
				-121.507166 °	-121.507166 °
DWR ID					
Action/Comments					
Inspector Comments: FS_ID:41421 DS_ID:24905 EP_NO: N/A FS_HLM: 0.735 Repair Type: Non-Urgent Crossing Status: Indicator Found UCIP Comments: Need to contact owner to determine status and permit number for crossing. FIELD_STRUCT_DESC: Corrugated metal drainage pipe through floodwall visible on waterward side. FS Date: 03/06/2013

View of general area immediately downstream from crossing.

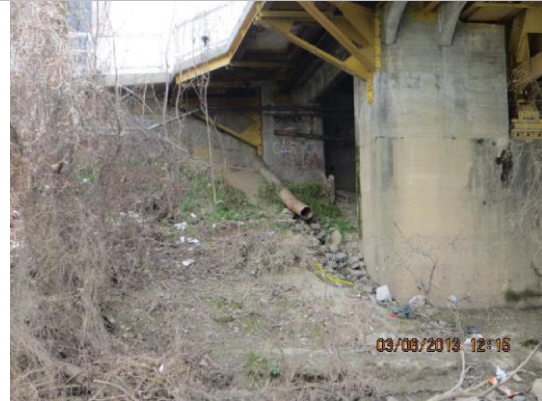
Photo 3 of 3 : UCIP_FA_2015_5936.jpg

LM Start	0.73	Rating **	M	Issue No.	851 (cont)
LM End	0.73	Issue Type +	En	Location *	N/A
Category	Supplemental			GPS Latitude/Longitude	
				Start	End
Item	DWR UCIP Field Study			38.580413 °	38.580413
				-121.507166 °	-121.507166
DWR ID					
Action/Comments					
Inspector Comments: FS_ID:41421					
DS_ID:24905					
EP_NO: N/A					
FS_HLM: 0.735					
Repair Type: Non-Urgent					
Crossing Status: Indicator Found

View of waterward side.

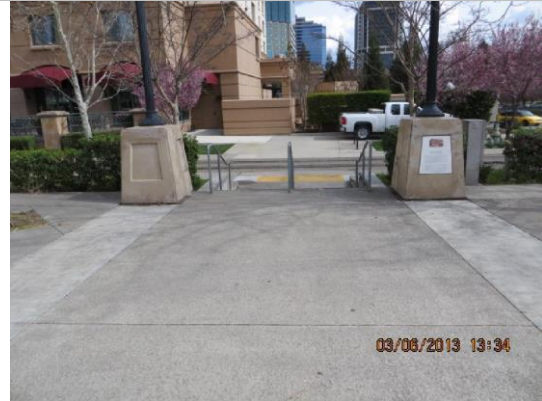
Photo 1 of 3 : UCIP_FA_2015_5937.jpg

LM Start	0.81	Rating **	M	Issue No.	854
LM End	0.81	Issue Type +	En	Location *	N/A
Category	Supplemental			GPS Latitude/Longitude	
				Start	End
Item	DWR UCIP Field Study			38.579353 °	38.579353 °
				-121.507560 °	-121.507560 °
DWR ID					
Action/Comments					
Inspector Comments: FS_ID:41422 DS_ID:24908 EP_NO: N/A FS_HLM: 0.812 Repair Type: Non-Urgent Crossing Status: Indicator Found UCIP Comments: Need to contact owner to determine status, purpose for lines, and permit number. FIELD_STRUCT_DESC: Cluster of conduits through floodwall visible from waterward side. FS Date: 03/06/2013

View of landward side.

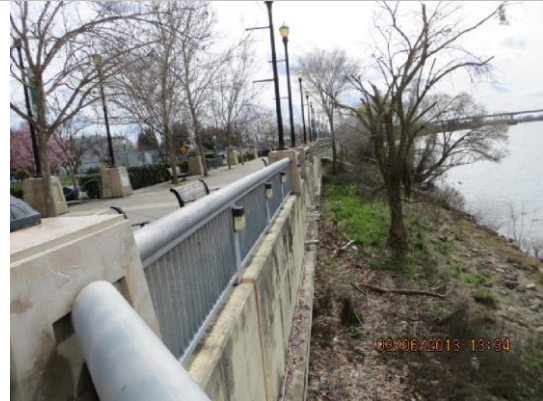
Photo 3 of 3 : UCIP_FA_2015_5948.jpg

LM Start	0.81	Rating **	M	Issue No.	854 (cont)
LM End	0.81	Issue Type +	En	Location *	N/A
Category	Supplemental			GPS Latitude/Longitude	
				Start	End
Item	DWR UCIP Field Study			38.579353 °	38.579353 °
				-121.507560 °	-121.507560 °
DWR ID					
Action/Comments					
Inspector Comments: FS_ID:41422					
DS_ID:24908					
EP_NO: N/A					
FS_HLM: 0.812					
Repair Type: Non-Urgent					
Crossing Status: Indicator Found

View of levee just downstream from crossings.

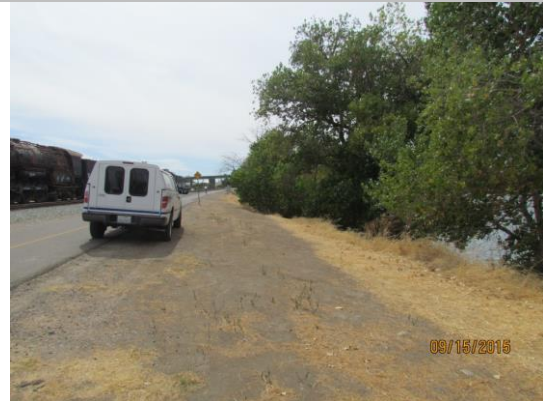
Photo 1 of 2 : FA_2015_NA0005_251_13_20150921_00024.jpg

LM Start	1.16	Rating **	A/W	Issue No.	13
LM End	1.69	Issue Type +	Ma	Location *	WS
Category	Earthen Levee			GPS Latitude/Longitude	
				Start	End
Item	Vegetation			38.574780 °	38.568757 °
				-121.510191 °	-121.515930 °
DWR ID	DWR_NA0005_01_f_2012_13				
Action/Comments					
Trees / Woody Vegetation

Monitor trees and woody vegetation along the rivers edge looking downstream. Fall 2015.

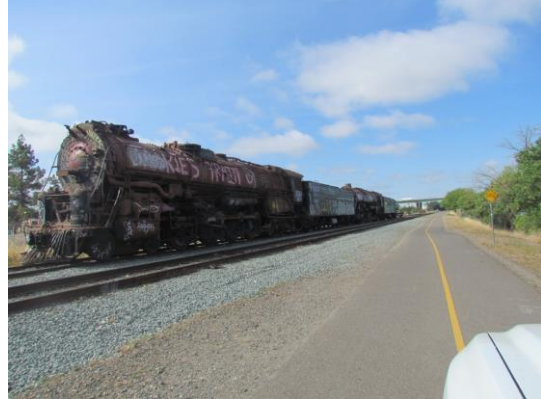
Photo 1 of 2 : FA_2015_NA0005_251_825_20150914_00017.jpg

LM Start	1.20	Rating **	M	Issue No.	825
LM End	1.20	Issue Type +	En	Location *	LS
Category	Earthen Levee			GPS Latitude/Longitude	
				Start	End
Item	Encroachments			38.574347 °	38.574347 °
				-121.510569 °	-121.510569 °
DWR ID	DWR_NA0005_01_s _ 2015_825				
Action/Comments					
Equipment					
Inspector Comments: There are two engines on the levee crown at this location.

View of the train on the landward side of the levee looking downstream.
Spring 2015.

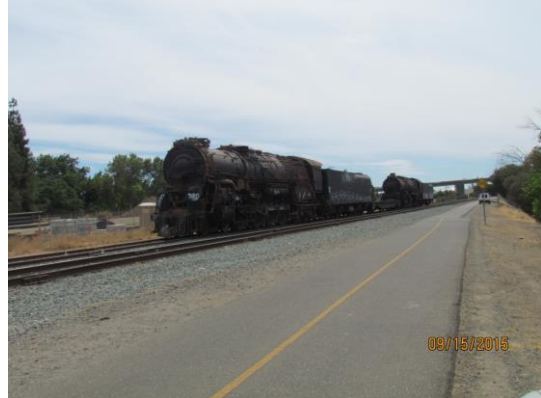
Photo 2 of 2 : FA_2015_NA0005_251_825_20150921_00025.jpg

View of the train on the landward side of the levee looking downstream.
Fall 2015.

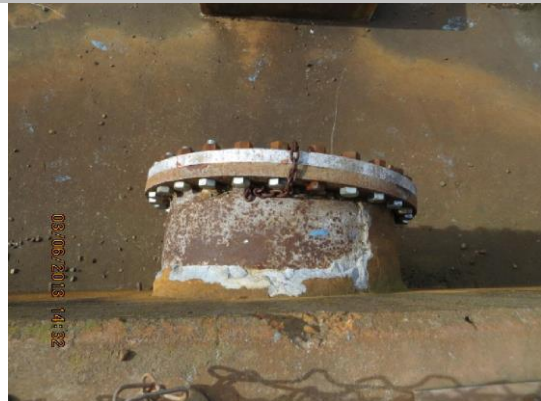
Photo 1 of 3 : UCIP_FA_2015_1810.jpg

LM Start	1.24	Rating **	M	Issue No.	855
LM End	1.24	Issue Type +	En	Location *	LS
Category	Supplemental			GPS Latitude/Longitude	
				Start	End
Item	DWR UCIP Field Study			38.573901 °	38.573901 °
				-121.511025 °	-121.511025 °
DWR ID					
Action/Comments					
Inspector Comments: FS_ID:41425					
DS_ID:21565					
EP_NO: 5140					
FS_HLM: 1.233					
Repair Type: Non-Urgent					
Crossing Status: Indicator Found

Metal plate used to cap off pipe.

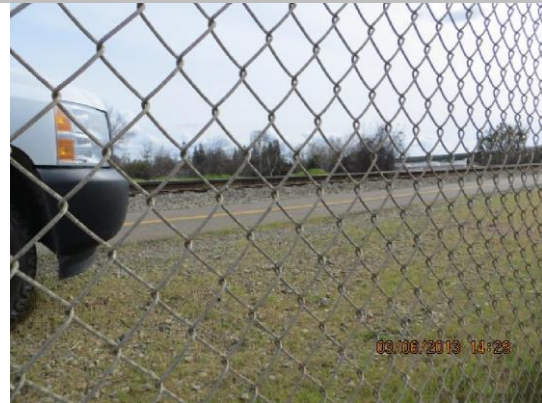
Photo 3 of 3 : UCIP_FA_2015_1876.jpg

Item	DWR UCIP Field Study			38.573901 °	38.573901 °	
				-121.511025 °	-121.511025 °	
DWR ID						
Action/Comments						
Inspector Comments: FS_ID:41425 DS_ID:21565 EP_NO: 5140 FS_HLM: 1.233 Repair Type: Non-Urgent Crossing Status: Indicator Found UCIP Comments: Need to determine more details pertaining to crossing, coordinate with City of Sacramento. Is crossing active? FIELD_STRUCT_DESC: 30-inch diameter condensing water pipe sleeved through 40-inch diameter pipe 5 feet below the crown, annular space grouted. Anchor blocks on both ends, concrete pipes under pads over pipe under railroad. Cap on the waterward end. A 1.5 foot thick by 8 foot high by 8 foot wide reinforced concrete headwall supported on a 2 foot thick by 5.5 foot wide by 12 foot long concrete footing. An 8 foot high by 64 foot wide apron constructed around the waterward end of the pipe at the waterward shoulder of the levee. (Permit No. 5140, State of California-Department of General Services-1967) 18-inch temporary diameter welded steel pipe sleeved through existing 30 inch used to convey water from construction site. (Permit No. 5745-1967) FS Date: 03/06/2013

View of railroad and bike path located on levee crown--wide levee.

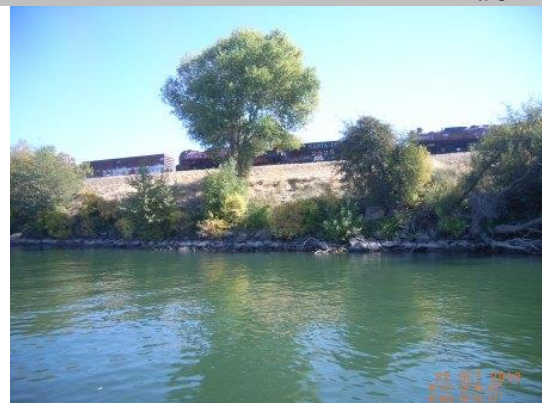
Photo 1 of 2 : USACE2013A_SAC_58-5_L_5.jpg

LM Start	1.31	Rating **	M	Issue No.	1
LM End	1.39	Issue Type +	Ma	Location *	WS
Category	Supplemental			GPS Latitude/Longitude	
				Start	End
Item	2015 USACE Erosion Survey, DRAFT			38.573169 °	38.572277 °
				-121.511998 °	-121.513063 °
DWR ID					
Action/Comments					
Inspector Comments: 2008 - Oversized levee, should be repaired under maintenance. 2009 - Shallow slumps at the mid bank. 2010 - Some minor erosion at the toe, likely from wave wash. Some new shallow slumps. 2011 - One new tree has fallen. 2013 - Erosion continues on the slope surface, site extended upstream. 2015: No observed changes. [2015 Site ID: SAC_58-5_L]

USACE 2013 Photo #1

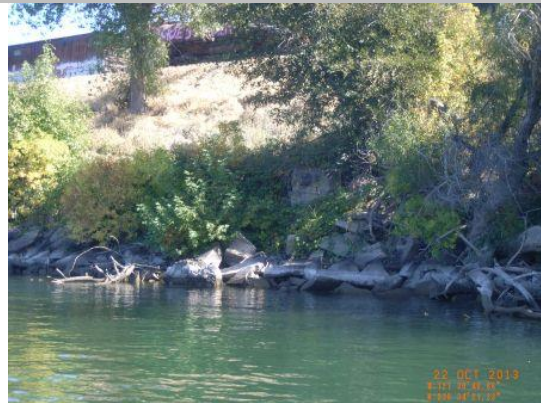
Photo 2 of 2 : USACE2013A_SAC_58-5_L_6.jpg

LM Start	1.31	Rating **	M	Issue No.	1 (cont)
LM End	1.39	Issue Type +	Ma	Location *	WS
Category	Supplemental			GPS Latitude/Longitude	
				Start	End
Item	2015 USACE Erosion Survey, DRAFT			38.573169 °	38.572277 °
				-121.511998 °	-121.513063 °
DWR ID					
Action/Comments					
Inspector Comments: 2008 - Oversized levee, should be repaired under maintenance. 2009 - Shallow slumps at the mid bank. 2010 - Some minor erosion at the toe, likely from wave wash. Some new shallow slumps. 2011 - One new tree has fallen. 2013 - Erosion continues on the slope surface, site extended upstream. 2015: No observed changes. [2015 Site ID: SAC_58-5_L]

USACE 2013 Photo #2

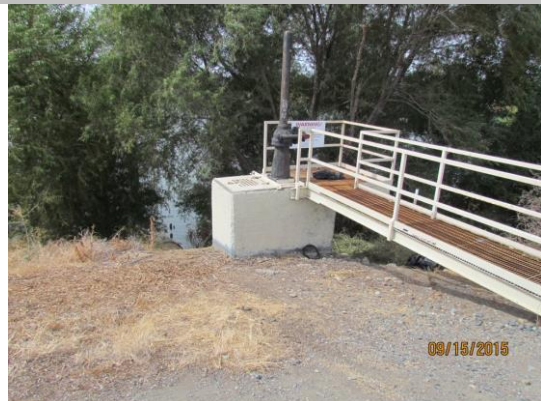
Photo 1 of 2 : FA_2015_NA0005_251_5_20150921_00026.jpg

LM Start	1.40	Rating **	A/W	Issue No.	5
LM End	1.40	Issue Type +	En	Location *	WS
Category	Earthen Levee			GPS Latitude/Longitude	
				Start	End
Item	Encroachments			38.572008 °	38.572008 °
				-121.513017 °	-121.513017 °
DWR ID	DWR_NA0005_01_s_2012_5				
Action/Comments					
Pipe

An updated picture of the positive closure for the pipe. Fall 2015.

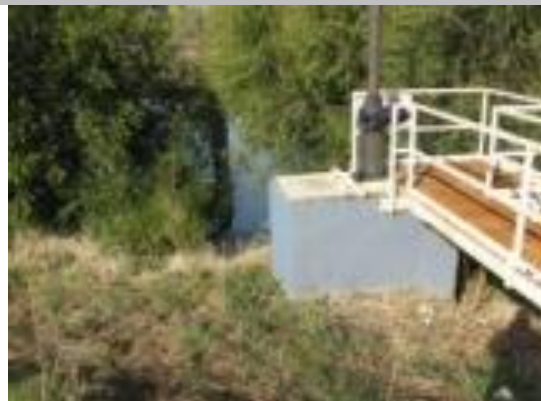
Photo 2 of 2 : FA_2015_NA0005_251_5_20150914_00001.jpg

The screw gate is the positive closure for the pipe. Fall 2011

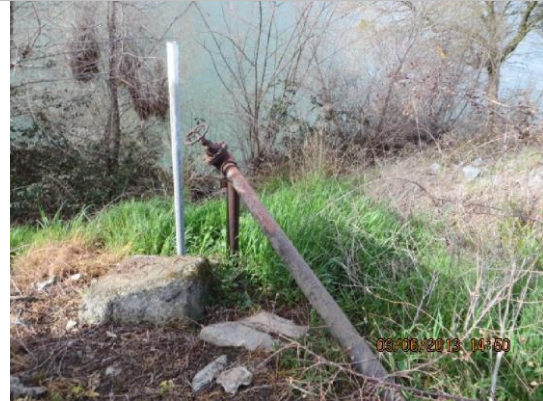
Photo 1 of 2 : UCIP_FA_2015_1803.jpg

LM Start	1.41	Rating **	M	Issue No.	856
LM End	1.41	Issue Type +	En	Location *	WS
Category	Supplemental			GPS Latitude/Longitude	
				Start	End
Item	DWR UCIP Field Study			38.572019 °	38.572019 °
				-121.513082 °	-121.513082 °
DWR ID					
Action/Comments					
Inspector Comments: FS_ID:20105					
DS_ID:21580					
EP_NO: N/A					
FS_HLM: 1.409					
Repair Type: Non-Urgent					
Crossing Status: Found

View of pipe and gate valve located on waterward slope.

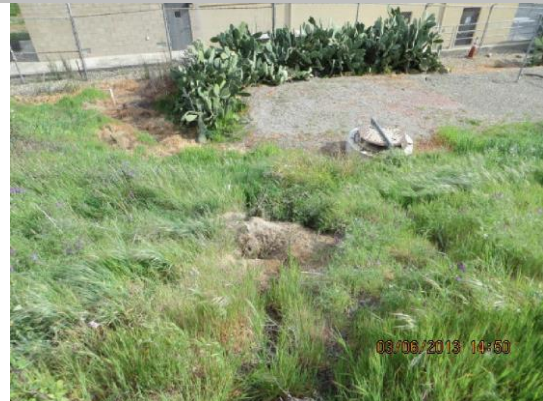
Photo 2 of 2 : UCIP_FA_2015_1804.jpg

View of landward side where crossing should be running through.

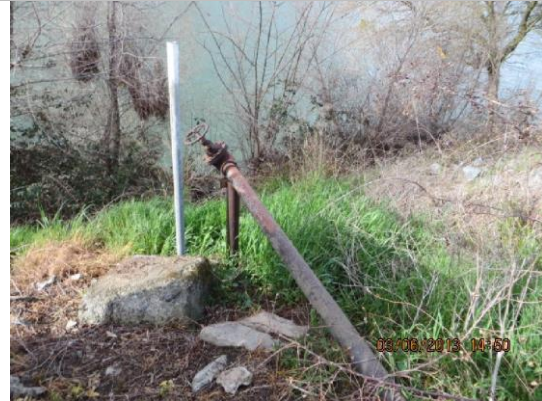
Photo 1 of 2 : UCIP_FA_2015_1805.jpg

LM Start	1.41	Rating **	U	Issue No.	857
LM End	1.41	Issue Type +	En	Location *	WS
Category	Supplemental			GPS Latitude/Longitude	
				Start	End
Item	DWR UCIP Field Study			38.572018 °	38.572018 °
				-121.513081 °	-121.513081 °
DWR ID					
Action/Comments					
Inspector Comments: FS_ID:42848					
DS_ID:21969					
EP_NO: N/A					
FS_HLM: 1.411					
Repair Type: Urgent					
Crossing Status: Found

View of 6 inch pipe and shut-off valve located on waterward slope.

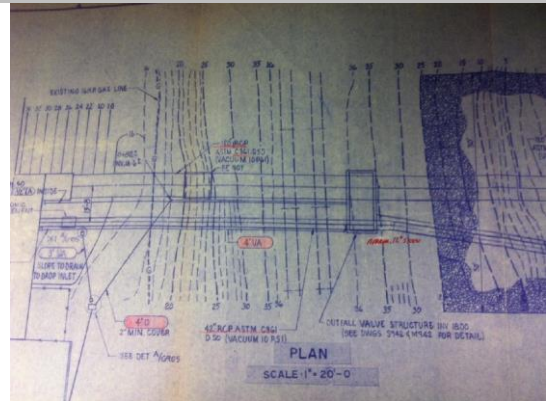
Photo 1 of 3 : UCIP_FA_2015_1988.jpg

LM Start	1.43	Rating **	M	Issue No.	859
LM End	1.43	Issue Type +	En	Location *	WS
Category	Supplemental			GPS Latitude/Longitude	
				Start	End
Item	DWR UCIP Field Study			38.571790 °	38.571790 °
				-121.513323 °	-121.513323 °
DWR ID					
Action/Comments					
Inspector Comments: FS_ID:20087 DS_ID:22483 EP_NO: 12196 FS_HLM: 1.43 Repair Type: Non-Urgent Crossing Status: Found UCIP Comments: Vault located on levee crown (bike path) and siphon breaker located on waterward shoulder. Coordinate with City of Sacramento to determine the condition of this crossing and last inspection. FIELD_STRUCT_DESC: 1 or 2: 42-inch RCP wash water intake pipe through levee at approximately 10 feet below crown. Line extends approximately 145 feet waterward from the reservoir to the outfall structure at the waterward shoulder of the levee. Pipe is skewed approximately 12 degrees upstream. Water Intake structure with screen. Waterward slope is armored by rock slope protection. Rock slope protection perimeter exists at river intake. (Permit No. 12196, Sacramento Regional County Sanitation District-1981). Permit 16611 was issued in 1996 to reline the inside of the pipe. FS Date: 03/06/2013

DWG showing 42-inch and 120-inch pipes through levee and connection to outfall valve structure.

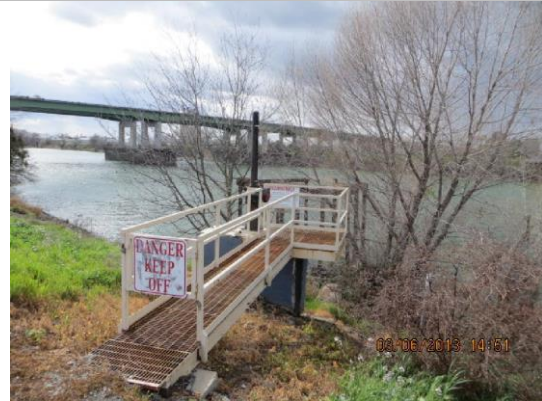
Photo 2 of 3 : UCIP_FA_2015_2026.jpg

Action/Comments					
Inspector Comments: FS_ID:20087 DS_ID:22483 EP_NO: 12196 FS_HLM: 1.43 Repair Type: Non-Urgent Crossing Status: Found UCIP Comments: Vault located on levee crown (bike path) and siphon breaker located on waterward shoulder. Coordinate with City of Sacramento to determine the condition of this crossing and last inspection. FIELD_STRUCT_DESC: 1 or 2: 42-inch RCP wash water intake pipe through levee at approximately 10 feet below crown. Line extends approximately 145 feet waterward from the reservoir to the outfall structure at the waterward shoulder of the levee. Pipe is skewed approximately 12 degrees upstream. Water Intake structure with screen. Waterward slope is armored by rock slope protection. Rock slope protection perimeter exists at river intake. (Permit No. 12196, Sacramento Regional County Sanitation District-1981). Permit 16611 was issued in 1996 to reline the inside of the pipe. FS Date: 03/06/2013

Walkway present on waterward shoulder.

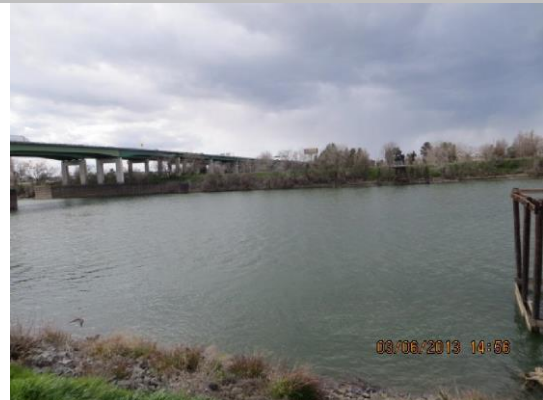
Photo 2 of 3 : UCIP_FA_2015_2035.jpg

LM Start	1.43	Rating **	M	Issue No.	860
LM End	1.43	Issue Type +	En	Location *	WS
Category	Supplemental			GPS Latitude/Longitude	
				Start	End
Item	DWR UCIP Field Study			38.571776 °	38.571776 °
				-121.513364 °	-121.513364 °
DWR ID					
Action/Comments					
Inspector Comments: FS_ID:41280 DS_ID:21569 EP_NO: 12196 FS_HLM: 1.432 Repair Type: Non-Urgent Crossing Status: Found UCIP Comments: Check with City of Sacramento to determine last inspection and condition of crossing. Vegetation on waterward and landward slope makes it difficult to inspect and identify any potential leaks visible from surface. FIELD_STRUCT_DESC: 2 of 2: 120-inch RCP outfall pipe extends approximately 117 feet waterward from the reservoir to a reinforced concrete outfall valve structure located in the levee crown. Waterward slope is armored by rock slope protection. Rock slope protection perimeter exists at outlet. (Permit No. 12196, Sacramento Regional County Sanitation District-1977). (Permit No. 12196, Sacramento Regional Sanitation District-1981). FS Date: 03/06/2013

View of waterward side--outlet submerged.

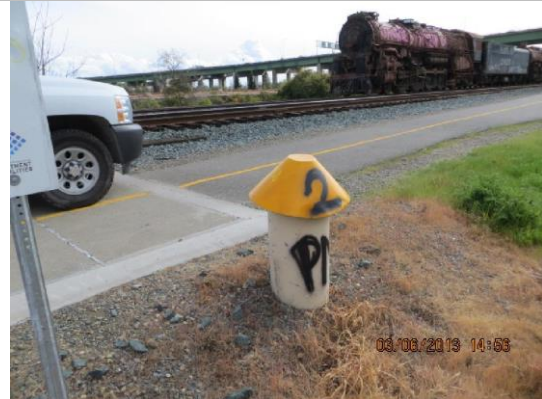
Photo 3 of 3 : UCIP_FA_2015_2036.jpg

LM Start	1.43	Rating **	M	Issue No.	860 (cont)
LM End	1.43	Issue Type +	En	Location *	WS
Category	Supplemental			GPS Latitude/Longitude	
				Start	End
Item	DWR UCIP Field Study			38.571776 °	38.571776 °
				-121.513364 °	-121.513364 °
DWR ID					
Action/Comments					
Inspector Comments: FS_ID:41280					
DS_ID:21569					
EP_NO: 12196					
FS_HLM: 1.432					
Repair Type: Non-Urgent					
Crossing Status: Found

View of levee crown--outlet valve structure located along bike path and siphon breaker on waterward shoulder.

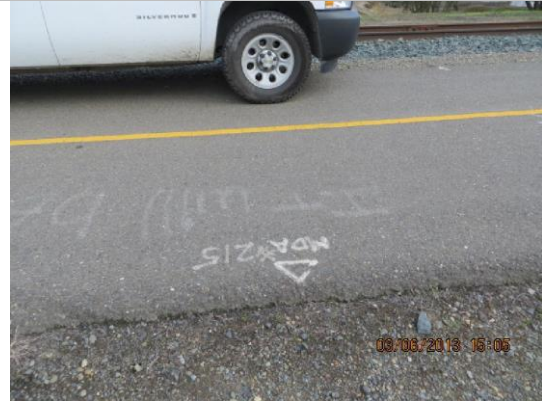
Photo 1 of 3 : UCIP_FA_2015_1241.jpg

Inspector Comments: FS_ID:32883
 DS_ID:21558
 EP_NO: 2371
 FS_HLM: 1.594
 Repair Type: Non-Urgent
 Crossing Status: Found
 UCIP Comments: Need to coordinate with PG&E to clarify all appurtenances associated with crossing. Need maintenance records for this crossing (last inspection).
 FIELD_STRUCT_DESC: 12-inch pipe through the levee, 5.0 feet below the crown. Gas pipeline sign on the waterward slope and rectangular concrete box on the waterward berm. (Permit No. 2371-PG&E, 1959).
 FS Date: 03/06/2013

View of levee crown (trail) near waterward shoulder edge.

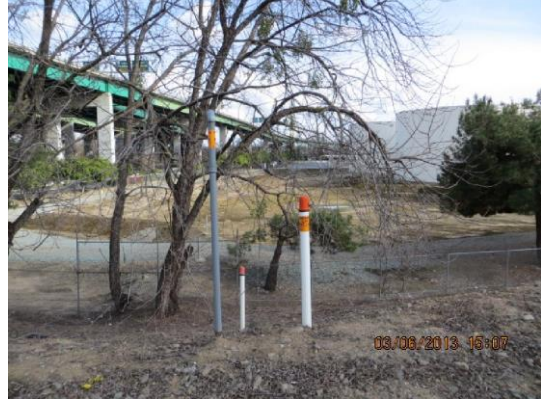
Photo 1 of 3 : UCIP_FA_2015_4638.jpg

LM Start	1.61	Rating **	M	Issue No.	864
LM End	1.61	Issue Type +	En	Location *	WS
Category	Supplemental			GPS Latitude/Longitude	
				Start	End
Item	DWR UCIP Field Study			38.569806 °	38.569806 °
				-121.515546 °	-121.515546 °
DWR ID					
Action/Comments					
Inspector Comments: FS_ID:41442 DS_ID:21617 EP_NO: 14732 FS_HLM: 1.614 Repair Type: Non-Urgent Crossing Status: Found UCIP Comments: Need to obtain maintenance records for pipe line-- Inspector was able to obtain inspection status from PG&E. FIELD_STRUCT_DESC: 24 inch diameter natural gas pipeline under the levee and channel at a depth of 25 feet minimum. (Permit No. 14732, PG&E-1988) FS Date: 03/07/2013

View of stand pipes located on landward side.

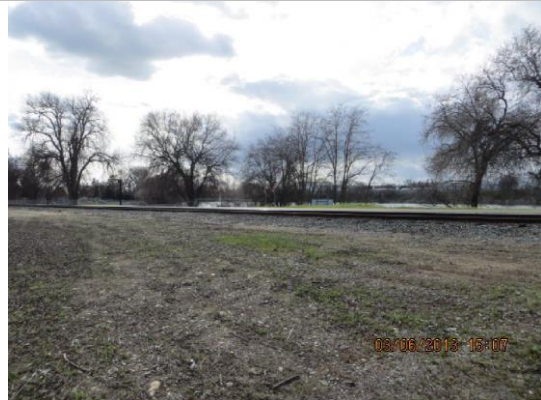
Photo 2 of 3 : UCIP_FA_2015_4639.jpg

View of crossing approximately 110 feet downstream--large sign located on waterward slope.

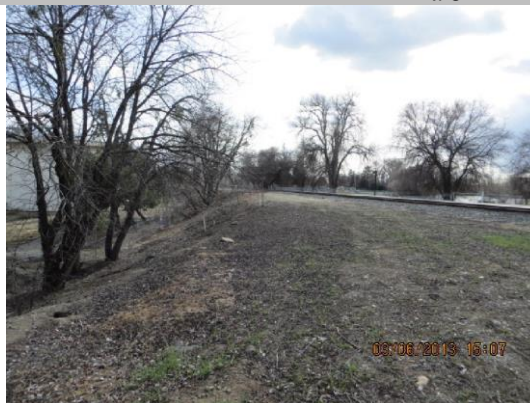
Photo 3 of 3 : UCIP_FA_2015_4640.jpg

LM Start	1.61	Rating **	M	Issue No.	864 (cont)
LM End	1.61	Issue Type +	En	Location *	WS
Category	Supplemental			GPS Latitude/Longitude	
				Start	End
Item	DWR UCIP Field Study			38.569806 °	38.569806 °
				-121.515546 °	-121.515546 °
DWR ID					
Action/Comments					
Inspector Comments: FS_ID:41442					
DS_ID:21617					
EP_NO: 14732					
FS_HLM: 1.614					
Repair Type: Non-Urgent					
Crossing Status: Found

View of crossing approximately 110 feet downstream--stand pipes located on landward shoulder.

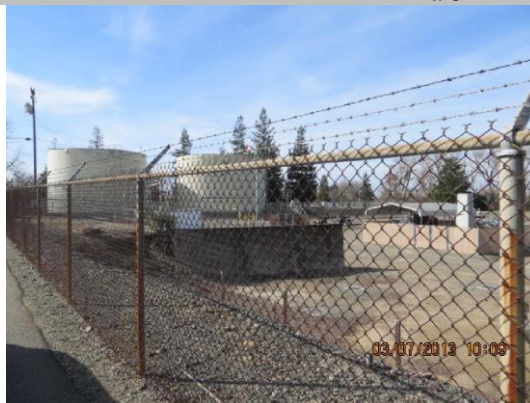
Photo 1 of 1 : UCIP_FA_2015_4265.jpg

LM Start	1.70	Rating **	M	Issue No.	865
LM End	1.70	Issue Type +	En	Location *	WS
Category	Supplemental			GPS Latitude/Longitude	
				Start	End
Item	DWR UCIP Field Study			38.568544 °	38.568544 °
				-121.515993 °	-121.515993 °
DWR ID					
Action/Comments					
Inspector Comments: FS_ID:41444 DS_ID:21615 EP_NO: 17185 FS_HLM: 1.703 Repair Type: Non-Urgent Crossing Status: Found UCIP Comments: Some buildings, structures, and equipment remain -- monitoring wells still present within acre footprint. Need to contact owner to determine status of monitoring site. FIELD_STRUCT_DESC: Removed oil tanks, holding racks, underground pipes, buildings and associated concrete slabs, footings, and foundations from the left bank of the Sacramento River. Demo site located on waterward berm from LM 1.68 (38.56893227, -121.5158786) to LM 1.74 (38.568074, -121.5160597). Demolition acceptance form signed November 2000. Exceptions or remaining features are present: 1. product piping and conduits through levee on the east side of site, abandoned in place, 2. existing electrical house located at the southeast corner of the property, 3. active conduits coming from existing electrical house and proceeding west approximately 30 feet, then south under Broadway to Tosco's active tanks located south of Broadway, and 4. 16 wooden piles 10 feet below ground surface in the middle of the site (former Tank #5009 area) FS Date: 03/07/2013

Concrete structure still remain in lot on waterward side.

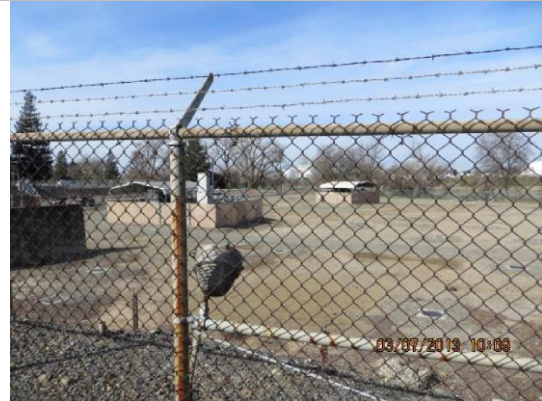
Photo 3 of 3 : UCIP_FA_2015_4268.jpg

Item	DWR UCIP Field Study			38.568491 °	38.568491 °	
				-121.515977 °	-121.515977 °	
DWR ID						
Action/Comments						
Inspector Comments: FS_ID:41282 DS_ID:21604 EP_NO: 18009 FS_HLM: 1.708 Repair Type: Non-Urgent Crossing Status: Found UCIP Comments: Project has reached 5 years is this project still in use? Permit issued for abandonment of treatment? Assumed installation date of 7/1/2005 per inspector's notes indicating work was completed in the summer of 2005. FIELD_STRUCT_DESC: Ozone Injection and Soil Vapor Extraction Treatment System for Former Tosco Bulk Fuel Terminal #3493. To authorize and retain (for approximately 5 years) twenty-three 2 to 4-inch-diameter extraction wells and thirty-six 2-inch-diameter ozone wells; to excavate approximately 2,050 linear-feet of trench and install required PVC piping and electrical conduits from the wells to main and sub-compounds with necessary equipment to complete an ozone injection and soil vapor extraction treatment system on the overflow area of the left (east) bank levee of the Sacramento River. FS Date: 03/07/2013

Structures present inside lot--site of Ozone Injection and Soil Vapor Extration System for the former Tosco Bulk Fuel.

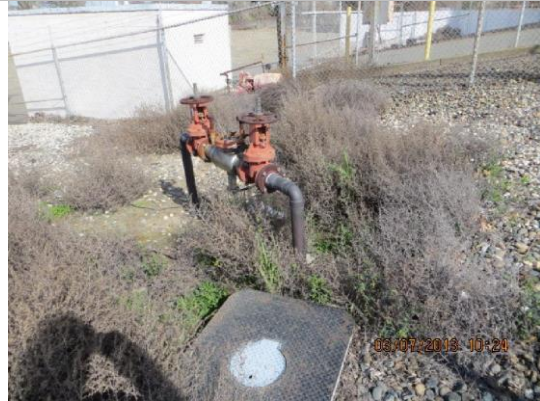
Photo 1 of 3 : UCIP_FA_2015_4142.jpg

LM Start	1.74	Rating **	M	Issue No.	868
LM End	1.74	Issue Type +	En	Location *	WS
Category	Supplemental			GPS Latitude/Longitude	
				Start	End
Item	DWR UCIP Field Study			38.567981 °	38.567981 °
				-121.516077 °	-121.516077 °
DWR ID					
Action/Comments					
Inspector Comments: FS_ID:41427					
DS_ID:21575					
EP_NO: 9259					
FS_HLM: 1.744					
Repair Type: Non-Urgent					
Crossing Status: Indicator Found					
UCIP Comments: Backflow device next to fence area angled--unable to confirm if device is part of crossing appurtenances.					
FIELD_STRUCT_DESC: 12-inch cast iron water main pipe sleeved through a 20-inch steel casing 3.0 feet below the crown elevation.					
(Permit No. 9259, City of Sacramento-1974)					
FS Date: 03/07/2013

Close up of positive closure device.

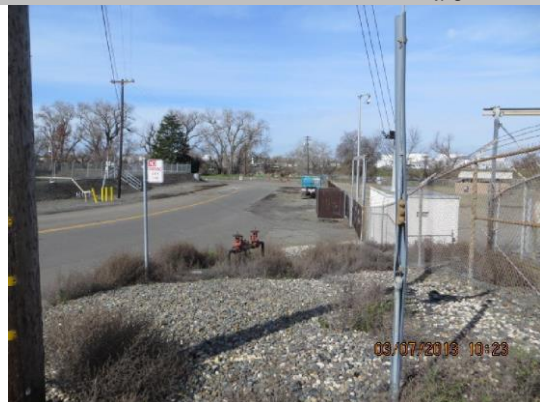
Photo 2 of 3 : UCIP_FA_2015_4143.jpg

Backflow prevention device on shoulder.

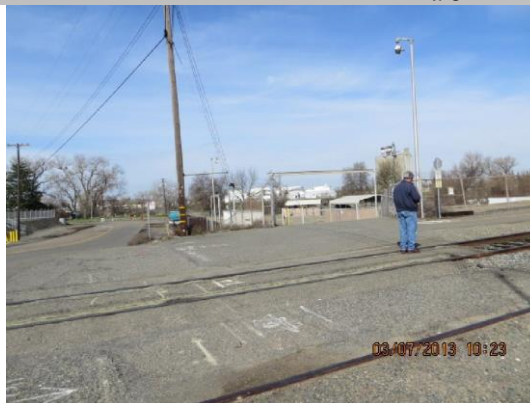
Photo 3 of 3 : UCIP_FA_2015_4144.jpg

LM Start	1.74	Rating **	M	Issue No.	868 (cont)
LM End	1.74	Issue Type +	En	Location *	WS
Category	Supplemental			GPS Latitude/Longitude	
				Start	End
Item	DWR UCIP Field Study			38.567981 °	38.567981 °
				-121.516077 °	-121.516077 °
DWR ID					
Action/Comments					
Inspector Comments: FS_ID:41427					
DS_ID:21575					
EP_NO: 9259					
FS_HLM: 1.744					
Repair Type: Non-Urgent					
Crossing Status: Indicator Found

View of wide levee crown--old railroad tracks, former Tosco Bulk Fuel Terminal #3493, utility poles, and fire hydrant.

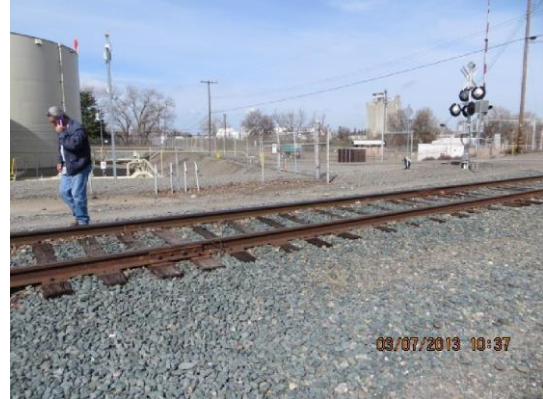
Photo 1 of 3 : UCIP_FA_2015_4153.jpg

LM Start	1.75	Rating **	M	Issue No.	870
LM End	1.75	Issue Type +	En	Location *	CR
Category	Supplemental			GPS Latitude/Longitude	
				Start	End
Item	DWR UCIP Field Study			38.567779 °	38.567779 °
				-121.516006 °	-121.516006 °
DWR ID					
Action/Comments					
Inspector Comments: FS_ID:41452					
DS_ID:21598					
EP_NO: 8816					
FS_HLM: 1.752					
Repair Type: Non-Urgent					
Crossing Status: Found

Pipe markers visible along chain link fence on waterward side.

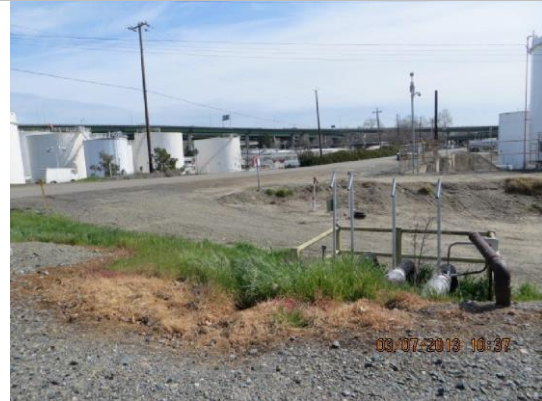
Photo 3 of 3 : UCIP_FA_2015_4155.jpg

LM Start	1.75	Rating **	M	Issue No.	870 (cont)
LM End	1.75	Issue Type +	En	Location *	CR
Category	Supplemental			GPS Latitude/Longitude	
				Start	End
Item	DWR UCIP Field Study			38.567779 °	38.567779 °
				-121.516006 °	-121.516006 °
DWR ID					
Action/Comments					
Inspector Comments: FS_ID:41452					
DS_ID:21598					
EP_NO: 8816					
FS_HLM: 1.752					
Repair Type: Non-Urgent					
Crossing Status: Found

View of crossings from levee shoulder.

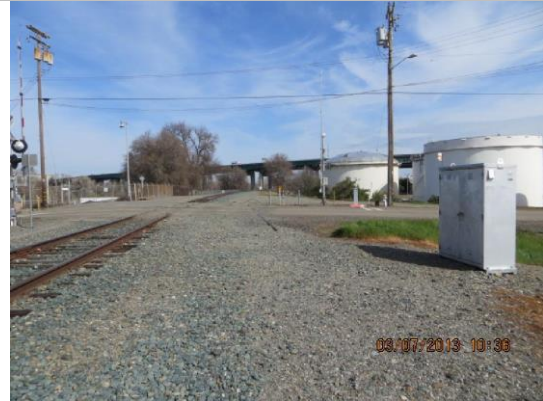
Photo 2 of 3 : UCIP_FA_2015_4146.jpg

Inspector Comments: FS_ID:41448
 DS_ID:22383
 EP_NO: 8816
 FS_HLM: 1.753
 Repair Type: Non-Urgent
 Crossing Status: Found
 UCIP Comments: High rodent on landward side. Dense vegetation limits the inspector's visibility to identify signs of pipe failure (leaks) through the slope. Recommend removing vegetation along pipe alignment to conduct proper inspection of structure and appurtenances.
 FIELD_STRUCT_DESC: 2 of 4: 10 inch line (premium) encased in 16 inch casing approximately 4 feet below crown. Vent pipes installed at each end of the conductor pipe. (Permit No. 8816, Phillips Petroleum Company-1974)
 FS Date: 03/07/2013

View of levee crown looking upstream--rail road traffic signal box located on right side.

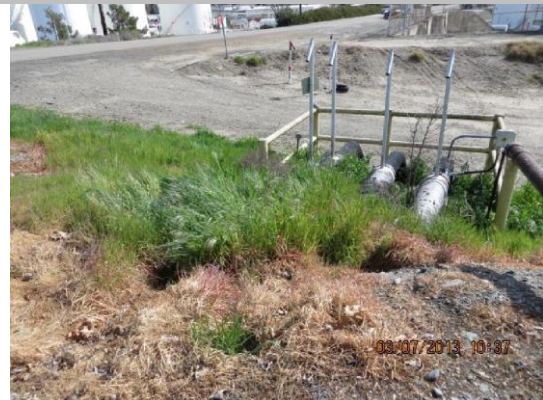
Photo 3 of 3 : UCIP_FA_2015_4147.jpg

Dense vegetation and large burrow holes located on shoulder.

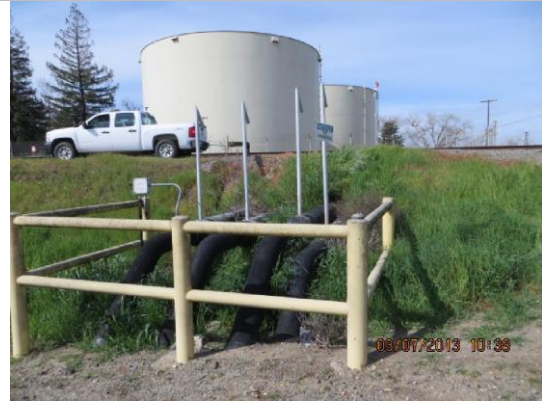
Photo 1 of 3 : UCIP_FA_2015_4148.jpg

LM Start	1.76	Rating **	M	Issue No.	872
LM End	1.76	Issue Type +	En	Location *	CR
Category	Supplemental			GPS Latitude/Longitude	
				Start	End
Item	DWR UCIP Field Study			38.567765 °	38.567765 °
				-121.516007 °	-121.516007 °
DWR ID					
Action/Comments					
Inspector Comments: FS_ID:41449					
DS_ID:22384					
EP_NO: 8816					
FS_HLM: 1.754					
Repair Type: Non-Urgent					
Crossing Status: Found

Pipes protected by metal post fence--landward side.

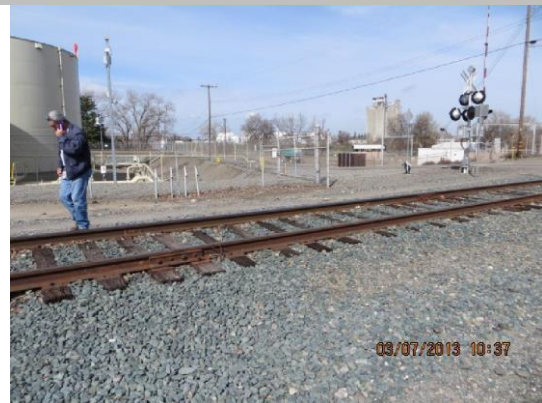
Photo 2 of 3 : UCIP_FA_2015_4149.jpg

View of waterward side--markers visible along chain link fence.

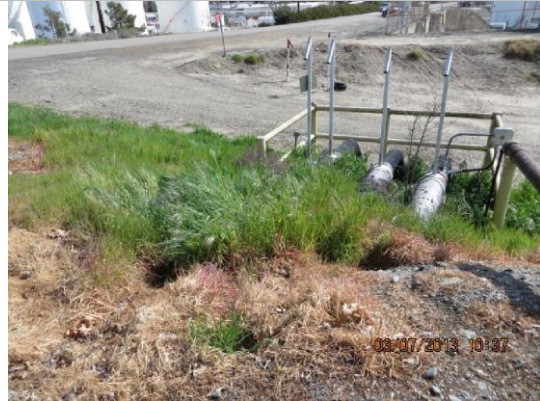
Photo 3 of 3 : UCIP_FA_2015_4150.jpg

LM Start	1.76	Rating **	M	Issue No.	872 (cont)
LM End	1.76	Issue Type +	En	Location *	CR
Category	Supplemental			GPS Latitude/Longitude	
				Start	End
Item	DWR UCIP Field Study			38.567765 °	38.567765 °
				-121.516007 °	-121.516007 °
DWR ID					
Action/Comments					
Inspector Comments: FS_ID:41449					
DS_ID:22384					
EP_NO: 8816					
FS_HLM: 1.754					
Repair Type: Non-Urgent					
Crossing Status: Found

View of 4-10 inch pipes through levee located on landward side.

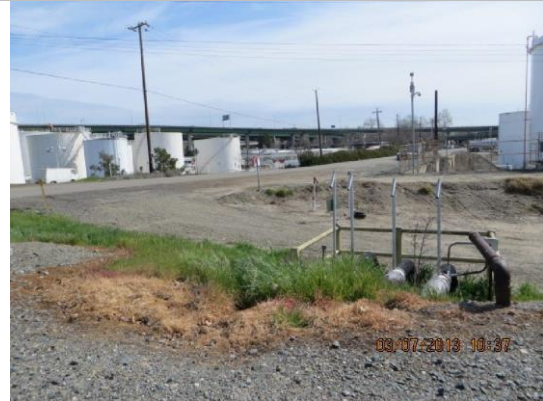
Photo 2 of 2 : UCIP_FA_2015_4152.jpg

LM Start	1.76	Rating **	M	Issue No.	873 (cont)
LM End	1.76	Issue Type +	En	Location *	CR
Category	Supplemental			GPS Latitude/Longitude	
				Start	End
Item	DWR UCIP Field Study			38.567759 °	38.567759 °
				-121.516007 °	-121.516007 °
DWR ID					
Action/Comments					
Inspector Comments: FS_ID:41455 DS_ID:22385 EP_NO: 8816 FS_HLM: 1.755 Repair Type: Non-Urgent Crossing Status: Found UCIP Comments: *5th pipe present (mystery pipe) 38.567748966, -121.516011521 not listed in permit* High rodent on landward side. Dense vegetation limits the inspector's visibility to identify signs of pipe failure (leaks) through the slope. Recommend removing vegetation along pipe alignment to conduct proper inspection of structure and appurtenances. FIELD_STRUCT_DESC: 4 of 4: 10 inch line (diesel) encased in 16 inch casing approximately 4 feet below crown. Vent pipes installed at each end of the conductor pipe. (Permit No. 8816, Phillips Petroleum Company-1974) FS Date: 03/07/2013

View multiple crossings visible on landward side.

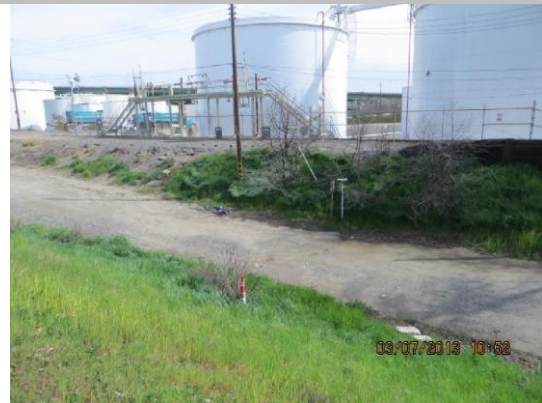
Photo 1 of 3 : UCIP_FA_2015_4156.jpg

LM Start	1.78	Rating **	M	Issue No.	874
LM End	1.78	Issue Type +	En	Location *	LS
Category	Supplemental			GPS Latitude/Longitude	
				Start	End
Item	DWR UCIP Field Study			38.567352 °	38.567352 °
				-121.516102 °	-121.516102 °
DWR ID					
Action/Comments					
Inspector Comments: FS_ID:41457					
DS_ID:21576					
EP_NO: 4914					
FS_HLM: 1.79					
Repair Type: Non-Urgent					
Crossing Status: Indicator Found					
UCIP Comments: Need records confirming crossing is free of leaks.					
FIELD_STRUCT_DESC: 8-inch pipe through the levee, 5.0 feet below the crown and along the waterward side to Levee Mile 2.41, for river crossing under the channel. (Permit No. 4914, A, B, C-Standard Oil Co.)					
FS Date: 03/07/2013

Markers visible on landward side.

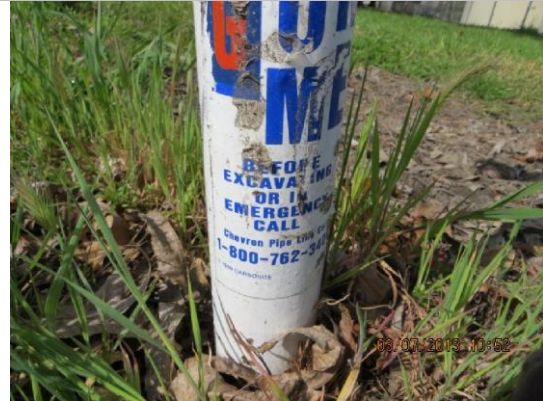
Photo 2 of 3 : UCIP_FA_2015_4157.jpg

Contact information before excavation or in case of emergency.

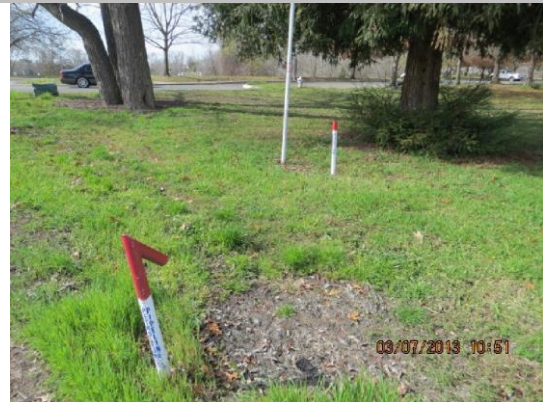
Photo 3 of 3 : UCIP_FA_2015_4158.jpg

View of waterward side--markers visible through levee.

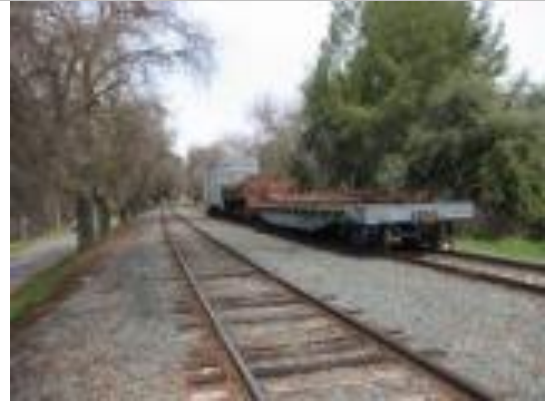
Photo 1 of 2 : FA_2015_NA0005_251_7_20150914_00002.jpg

LM Start	1.95	Rating **	M	Issue No.	7
LM End	2.34	Issue Type +	En	Location *	CR
Category	Earthen Levee			GPS Latitude/Longitude	
				Start	End
Item	Encroachments			38.564900 °	38.559460 °
				-121.516253 °	-121.515085 °
DWR ID	DWR_NA0005_01_f_2015_7				
Action/Comments					
Equipment					
Inspector Comments: Railroad tracks run on crown of levee, paved roadway runs along toe on waterside. This is Miller Park Marina area.

The railroad cars remain on the levee crown. Spring 2013

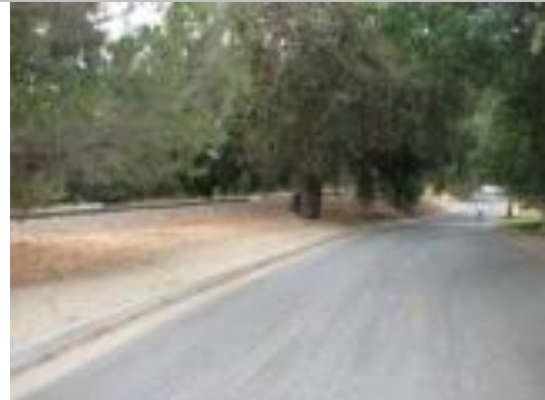
Photo 2 of 2 : FA_2015_NA0005_251_7_20150914_00003.jpg

Railroad tracks are on levee crown. The street is to the boat ramp.

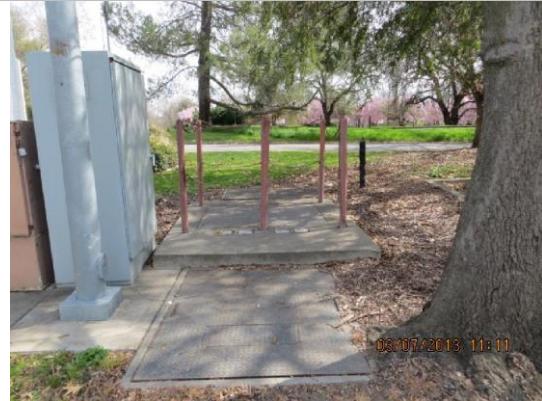
Photo 1 of 3 : UCIP_FA_2015_5949.jpg

LM Start	1.96	Rating **	M	Issue No.	876
LM End	1.96	Issue Type +	En	Location *	CR
Category	Supplemental			GPS Latitude/Longitude	
				Start	End
Item	DWR UCIP Field Study			38.564843 °	38.564843 °
				-121.516246 °	-121.516246 °
DWR ID					
Action/Comments					
Inspector Comments: FS_ID:41430					
DS_ID:21613					
EP_NO: 7434					
FS_HLM: 1.962					
Repair Type: Non-Urgent					
Crossing Status: Indicator Found

Service vault visible on levee crown.

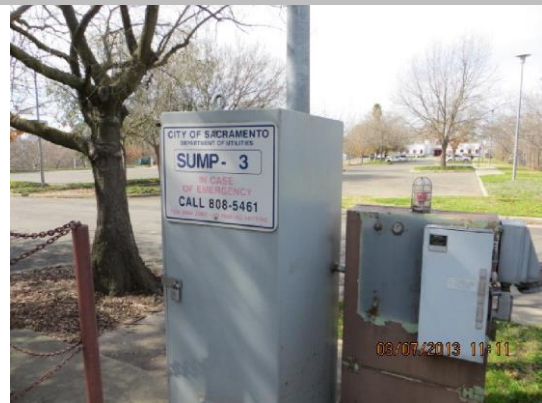
Photo 2 of 3 : UCIP_FA_2015_5950.jpg

Sump pump station 3.

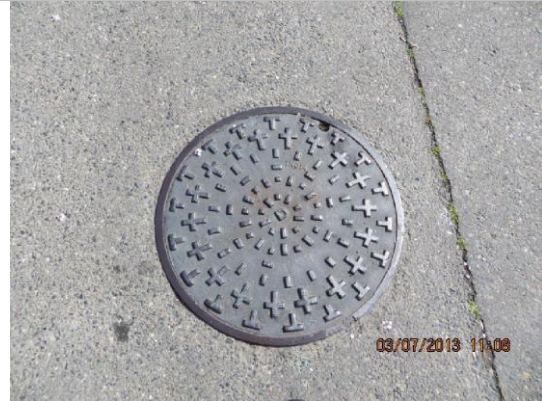
Photo 3 of 3 : UCIP_FA_2015_5951.jpg

LM Start	1.96	Rating **	M	Issue No.	876 (cont)
LM End	1.96	Issue Type +	En	Location *	CR
Category	Supplemental			GPS Latitude/Longitude	
				Start	End
Item	DWR UCIP Field Study			38.564843 °	38.564843
				-121.516246 °	-121.516246
DWR ID					
Action/Comments					
Inspector Comments: FS_ID:41430					
DS_ID:21613					
EP_NO: 7434					
FS_HLM: 1.962					
Repair Type: Non-Urgent					
Crossing Status: Indicator Found

Manhole present on roadway.

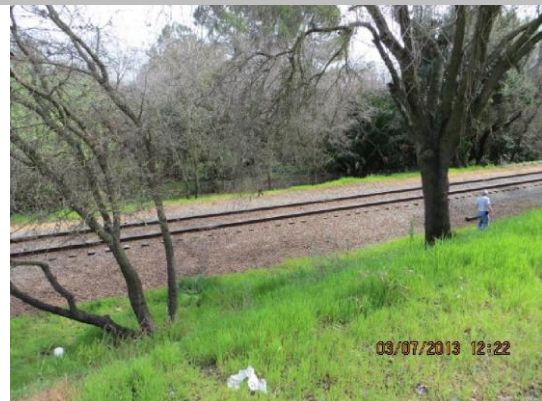
Photo 1 of 2 : UCIP_FA_2015_5953.jpg

LM Start	2.04	Rating **	M	Issue No.	881
LM End	2.04	Issue Type +	En	Location *	CR
Category	Supplemental			GPS Latitude/Longitude	
				Start	End
Item	DWR UCIP Field Study			38.563702 °	38.563702 °
				-121.515876 °	-121.515876 °
DWR ID					
Action/Comments					
Inspector Comments: FS_ID:41293 DS_ID:24921 EP_NO: N/A FS_HLM: 2.045 Repair Type: Non-Urgent Crossing Status: Indicator Found UCIP Comments: Need to contact owner to determine type of crossing and status. Need to find out the alignment of crossing. FIELD_STRUCT_DESC: 1 of 4. Crossing found through railroad/levee visible on landward side. FS Date: 03/06/2013

View of landward side.
